RARITAN RIVER BASIN  
CRAMERS CREEK, HUNTERDON COUNTY  
NEW JERSEY

NO NAME DAM NO. 31

NJ 00519

6 PHASE 1 INSPECTION REPORT  
NATIONAL DAM SAFETY PROGRAM.

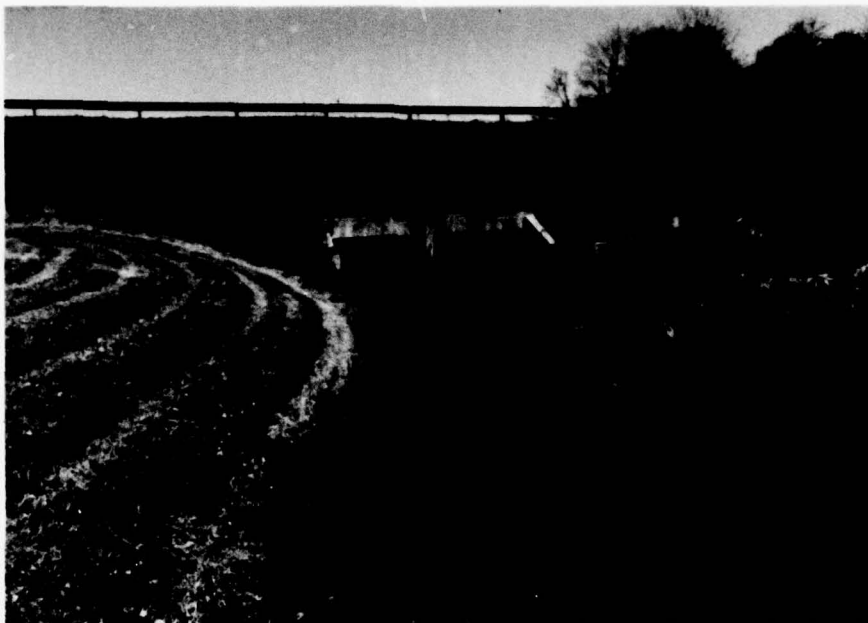
The double, rectangular discharge culvert is constructed of reinforced concrete and carries the flow from the spillway and low-level outlet through the embankment to the downstream channel. The right half of the discharge culvert is partially blocked by sediment deposited at the culvert exit and is otherwise in good condition.

Photo No. 1 - General view of embankment, spillway discharge culvert, and downstream channel. Note sedimentation and growth blocking right culvert.

d. Within six months from the date of approval of this report, the owner should remove sediment deposits from the low-level outlet and from the downstream channel.

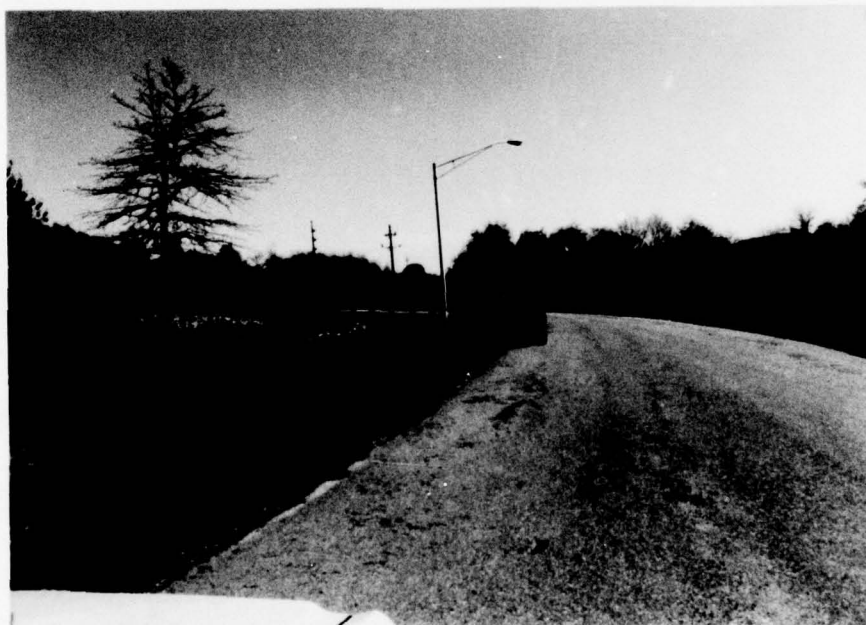
Photo No. 2 - View of road over embankment from right side. Note rip-rap on upstream face and box spillway (left of picture).

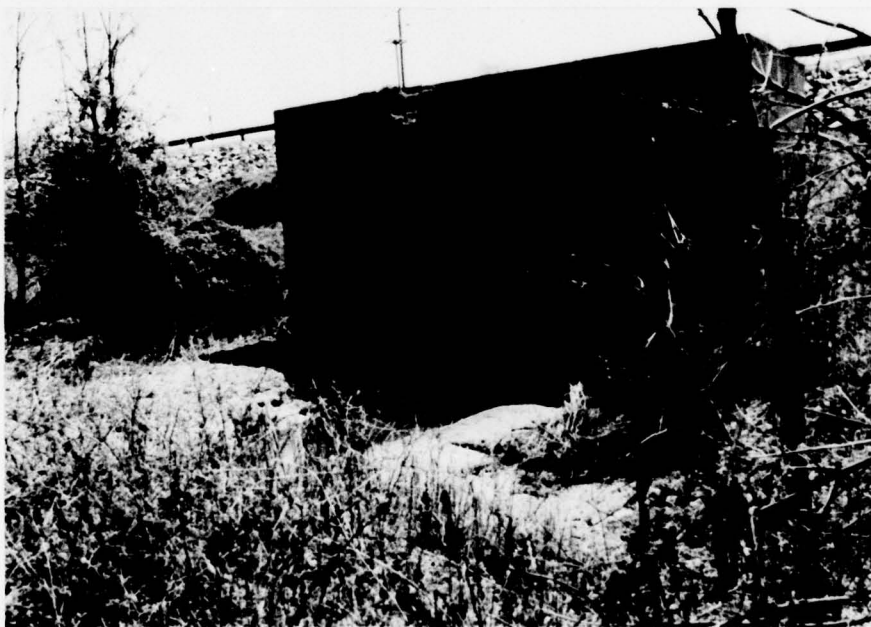
Photo No. 4 - Upstream face of box spillway. Note debris on top of corrugated gate well.

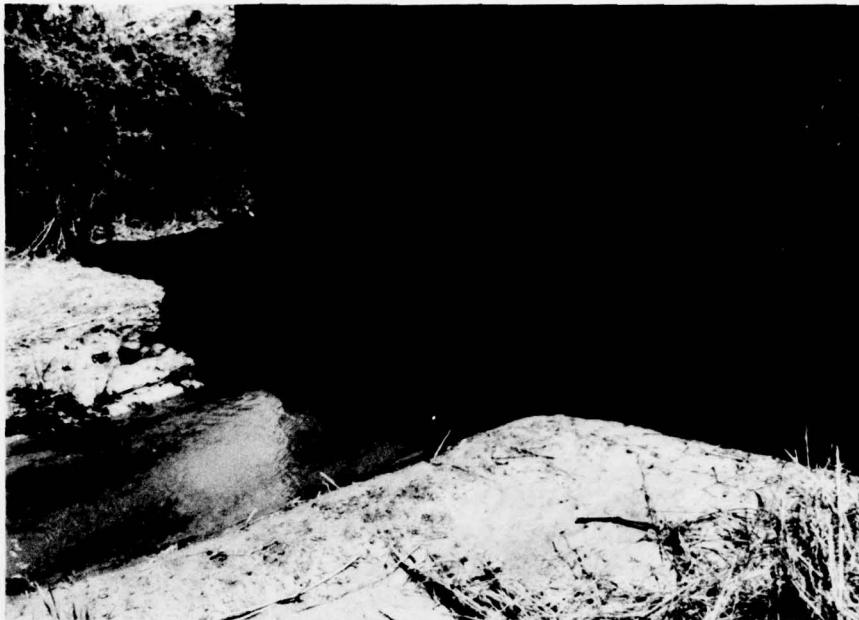
A 24" diameter manually operated sluice gate, installed on the upstream face of the box spillway, serves as a low-level outlet. The gate appears to be in good condition, but no proper means of access is provided for its operation. At present the handwheel can be operated only by standing on the spillway crest, which in turn can only be reached by ladder (with reservoir empty) or by boat (with reservoir full).

Photo No. 5 - Detail of low level outlet. Note sediment has almost blocked 24" diameter opening in corrugated gate well.

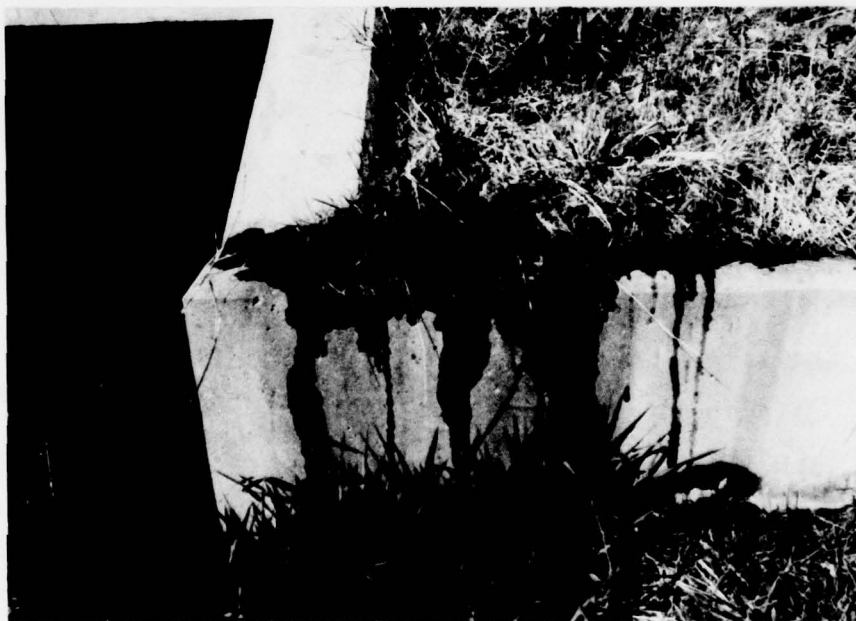
The embankment was found to be in good condition. Both slopes were regular and covered with grass and light brush. No sloughing or erosion was found, and the rip-rap protection on the upstream face was intact. Two wet areas were found on the downstream slopes, however, the reservoir was empty and it was concluded that the water was due to past rainfall.

Photo No. 6 - Detail of left wingwall at end of spillway discharge culvert. Seepage is from water retained in the embankment.
